The Safety Course Design and Operations of Composite Overwrapped Pressure Vessels (COPV)

Regor Saulsberry
William Prosser
25-29 May, 2015

- Although further refinements are likely, the modifications are now complete and a true multi-purpose COPV NDE scanner has resulted.
 - New sensors were developed and integrated into the expanded laser profilometry delivery system.
 - This new inspection system is potentially a “game changer” for production of safer and more reliable COPVs.
 - Can scan COPV liners up to 22-in diameter and 48-in long and internally and externally map thickness variations, map surfaces, provide Laser Video™ and detect very fine defects.
 - Highly accurate and calibrated internal mapping allows mechanical response evaluation and provides high-resolution images of the vessel interior.
 - Allows flaw screening and analysis after wrapping and autofrettage addressing a long standing technical concern over potential flaw generation and liner thinning during this time of plastic deformation.

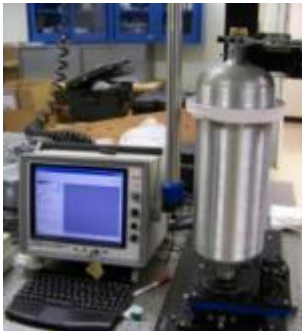
External EC added to
desktop profilometry
scanner

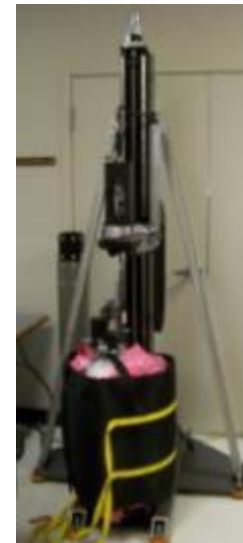
7'
Nitrogen/Oxygen
Recharge System
(NORS) and
Orion
profilometry
system
developed,
validated and
used extensively
by the ISS NORS
Program
